Manhole Inspection Summary

Manhole # S15QQ1028MH

Location Address: **2 CATALPA CT**

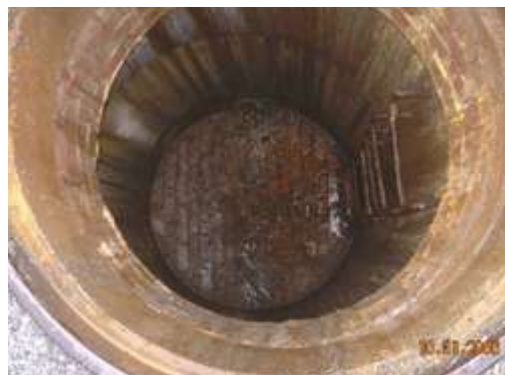
Top View

Channel debris.

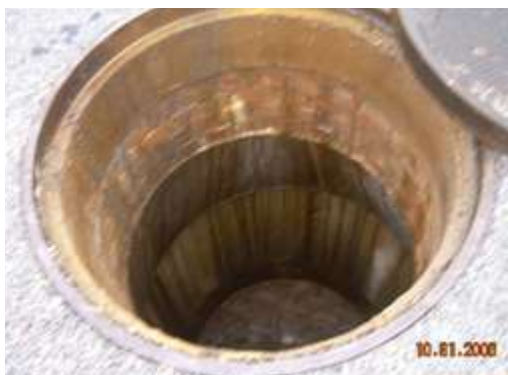
Defect

☒ **Leaks**

Infiltration: ☐ None ☒ **Joint** ☐ Cracks ☒ **Mortar** ☐ Roots ☐ Wall

Frame leaks. Adjustment infiltration.

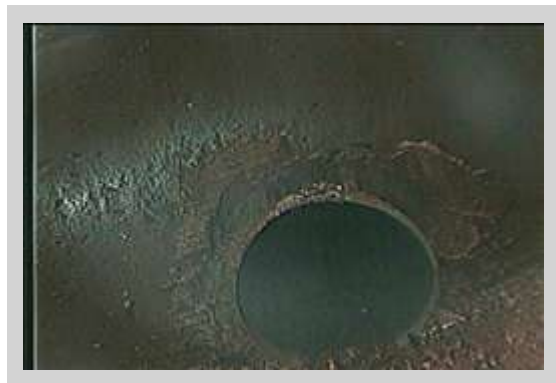
Pipe Out @ 12 O'Clock

Deposits: ☐ None ☒ **Mud** ☐ Sludge ☒ **Debris** ☐ Grease

Silt Depth: **0.5** (in.)

Infiltration: **Evidence**
